Rollins Ranch Association in Mountain Green

Level 1 Reserve Study

Report Period - 01/01/2015 - 12/31/2015

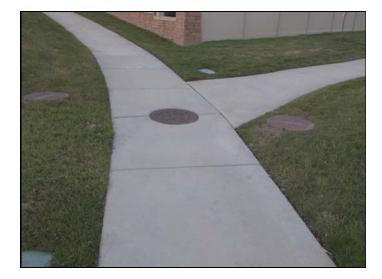
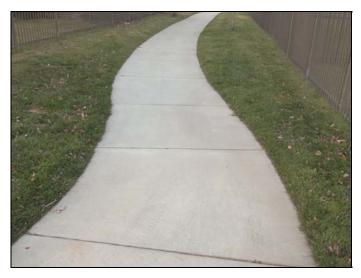
Comp #: 403 Concrete - Repair/Replace

The concrete is in good condition. Areas of cracking were noted at the time of the inspection. No expectation to completely replace the concrete surfaces. We recommend making local repairs as necessary as an operating expense and funding to make more significant repairs approximately every 10 years. Remaining life based on current age.

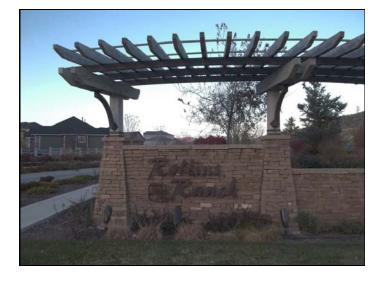
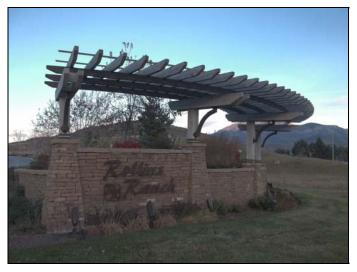
Comp #: 801 Entrance Monuments - Refurbish

The entrance monuments are in good condition. No problems were noted at the time of the inspection. We recommend funding to refurbish this component approximately every 15 - 18 years to ensure appearance. Remaining life is based on current age.

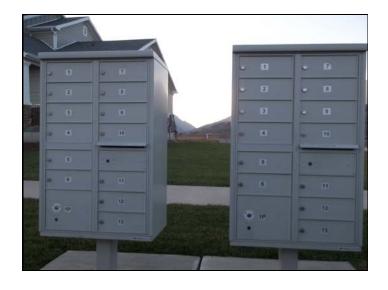
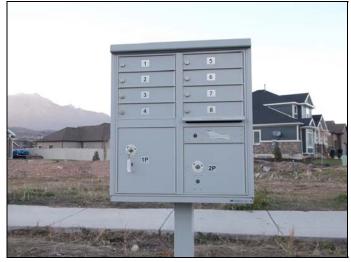
Comp #: 803 Mailboxes - Replace

The mailboxes are in good condition. No problems were noted at the time of the inspection. We recommend funding to replace this component approximately every 18 - 20 years assuming normal use and wear. Remaining life based on current average age.

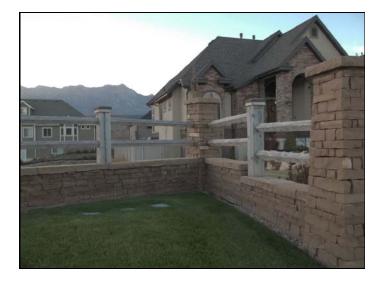
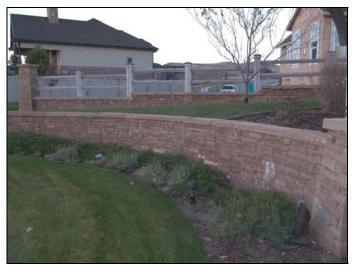
Comp #: 1005 Stone Walls - Repair

The stone walls are in good condition. No problems were noted at the time of the inspection. Although this component should experience an extended useful life, we recommend funding an allowance to make repairs to this component every 10 years. Remaining life based on current age.

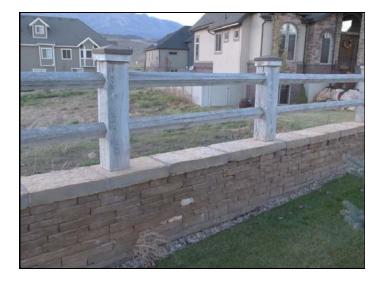
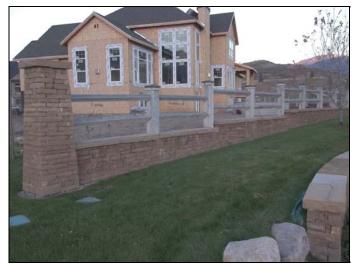
Comp #: 1009 Split Rail Fencing - Replace

The split rail fence is in fair condition. No problems were noted at the time of the inspection. We recommend funding to replace this component approximately every 15 - 20 years. Remaining life based on current age.

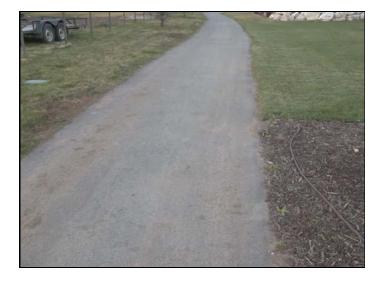
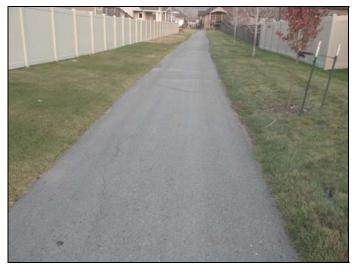
Comp #: 1390 Asphalt Trails - Repair/Seal

The asphalt trails are generally in good condition. Areas of cracking were noted at the time of the inspection. We recommend funding to seal/repair this component approximately every 6 years. Remaining life based on current age and condition.

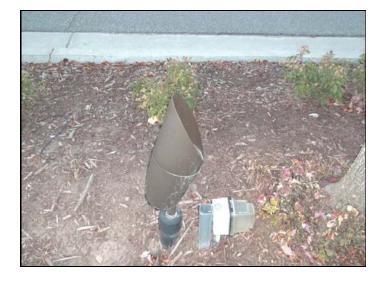
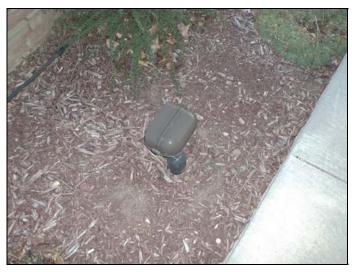
Comp #: 1603 Landscaping Light Fixtures - Replace

The landscaping light fixtures are generally in good condition. No problems were noted at the time of the inspection. We recommend funding to replace this component approximately every 12 - 15 years. Remaining life based on current age.

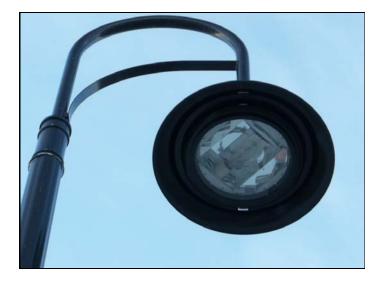
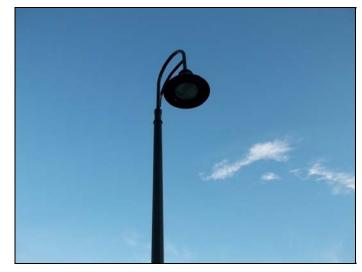
Comp #: 1609 Street Light Fixtures - Replace

The street light fixtures are in good condition. No problems were noted or reported at the time of the inspection. No expectation to replace the light poles. Paint poles as necessary as an operating expense. We recommend funding to replace this component approximately every 20 years to ensure proper function. Remaining life based on current average age.
